Building Inspection Report

Inspection Date:
XX-XX-XX

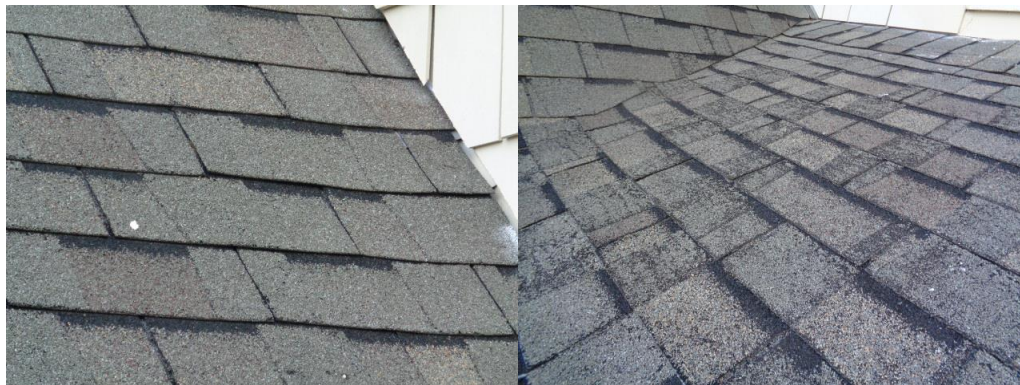
Weather conditions leading up to the inspection have been relatively dry.

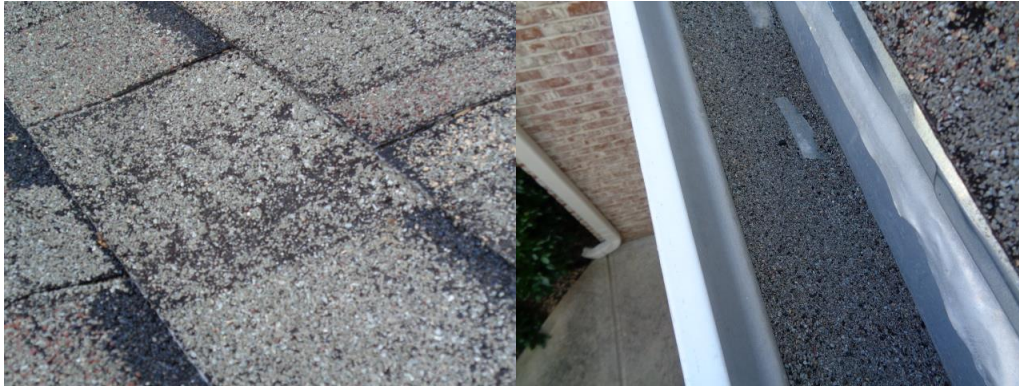
Atlas chalet shingle material noted at the home with excessive granule loss noted in areas.

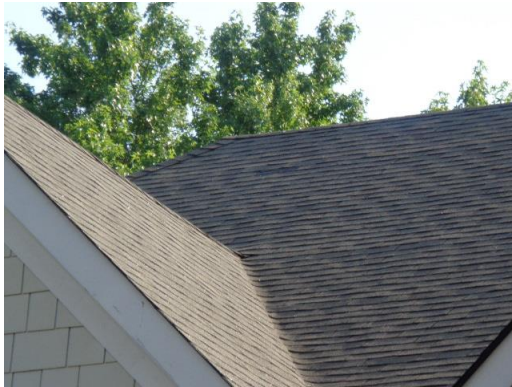
Missing roofing material noted at the front slope.

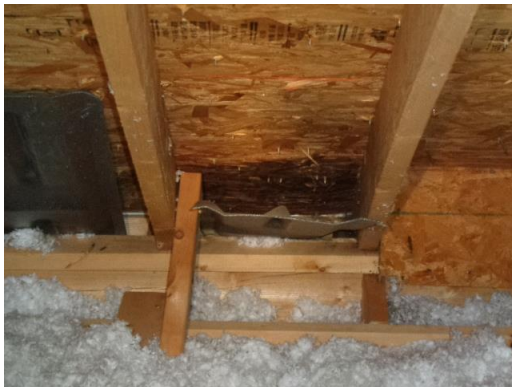
Evidence of roof leakage near the chimney chase.

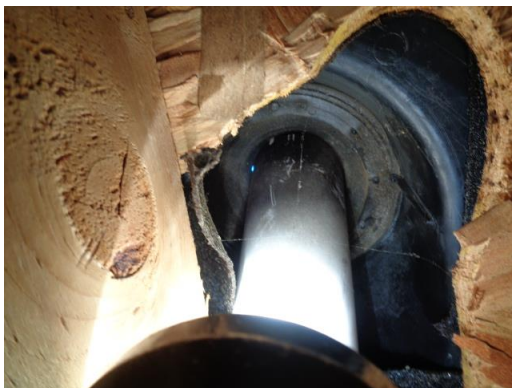
Light showing around neoprene boot flashings.

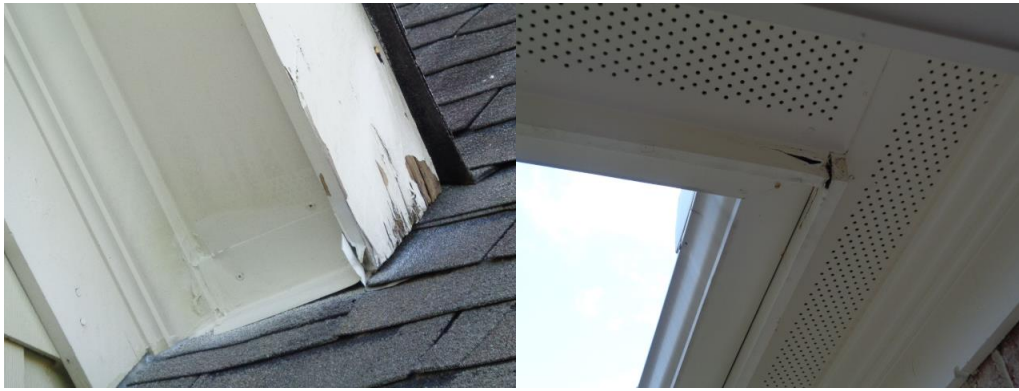
Localized rot noted in the fascia at the front of the home.

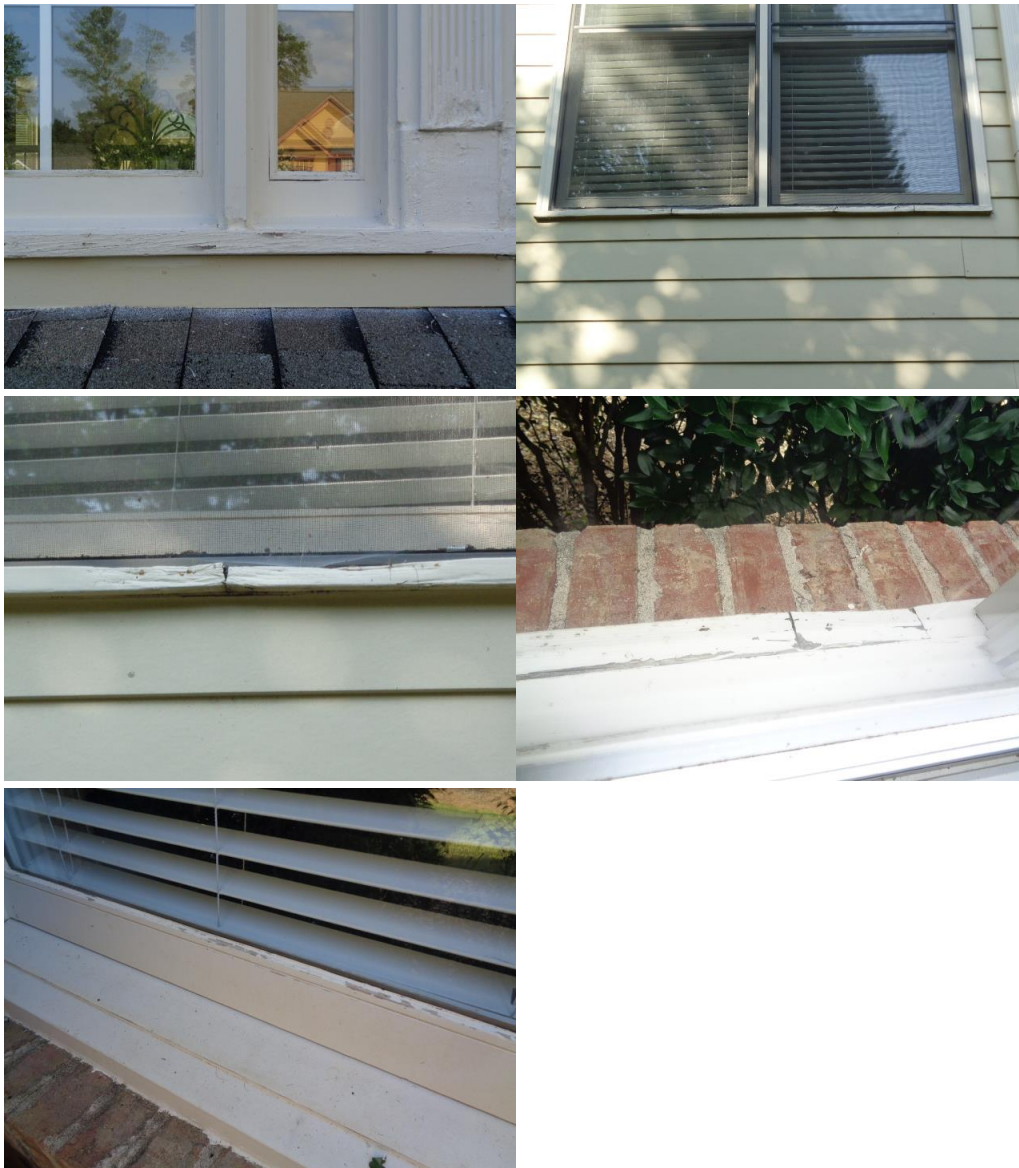
Localized rot noted in windows at the front and rear of the home with painting needed.

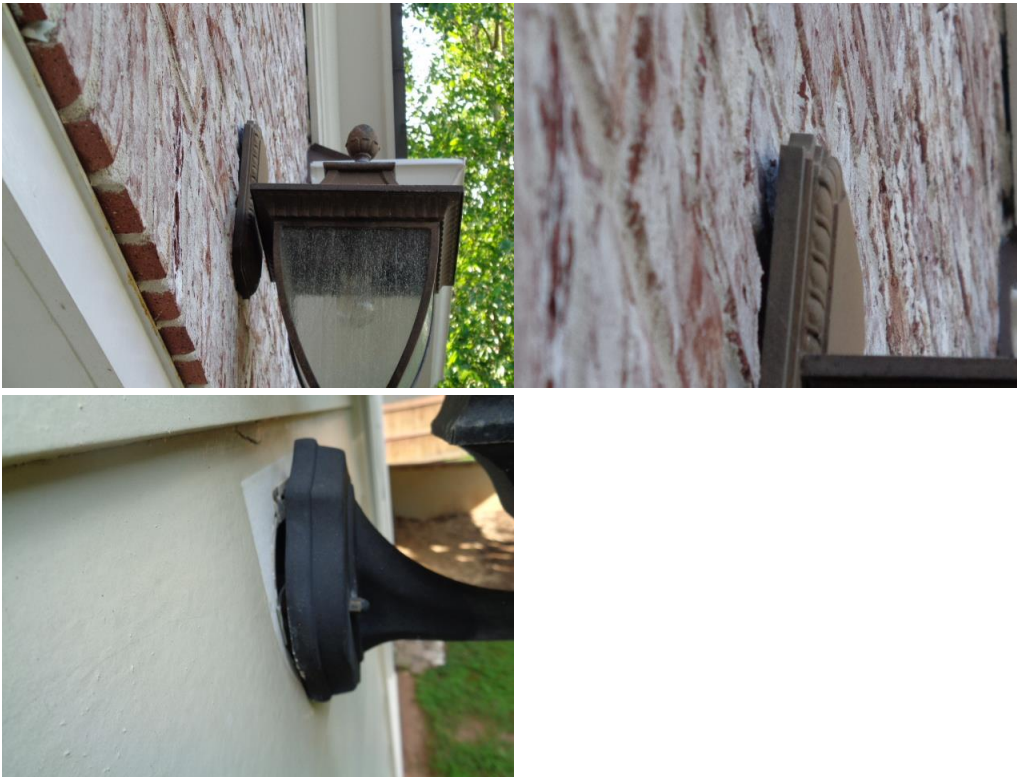
Recommend securing and sealing exterior light fixtures.

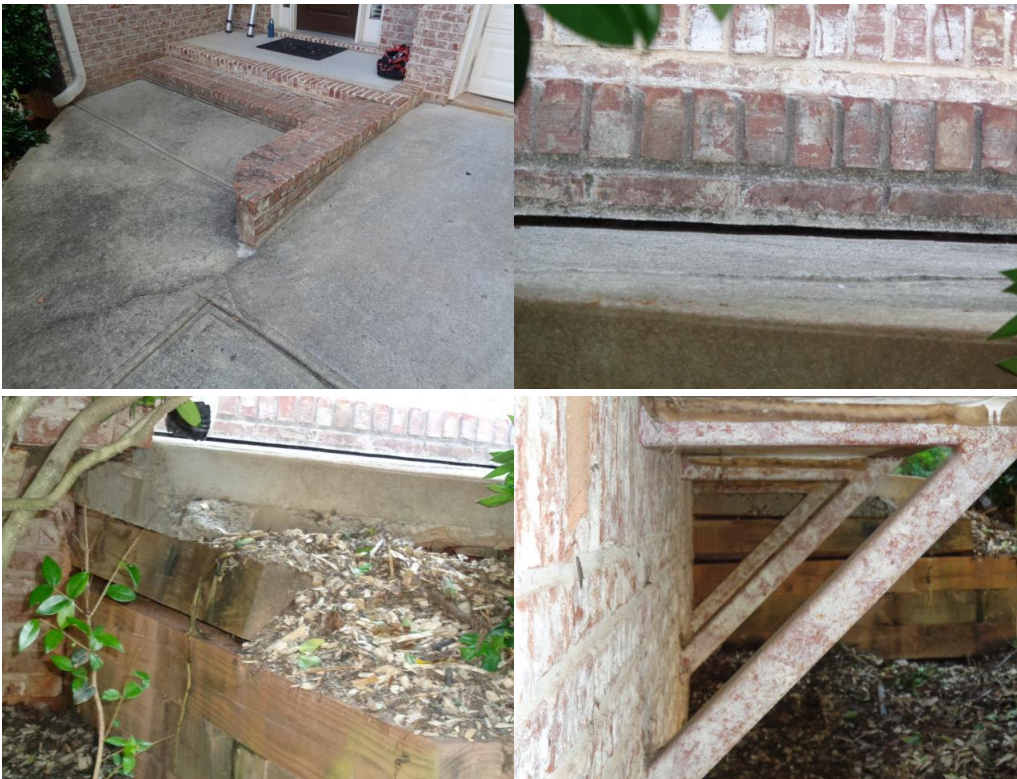
Settlement and backfill issues with movement in the retaining wall noted at the front entry.

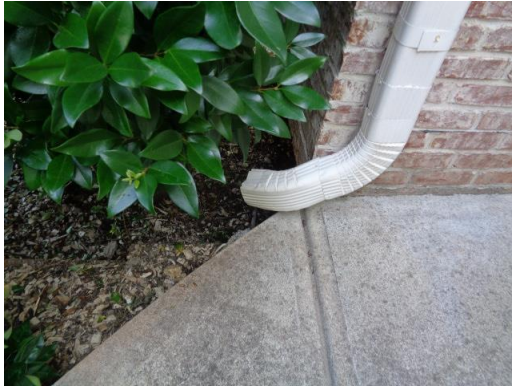
Recommend extending downspouts away from the vulnerable area at the front entry.

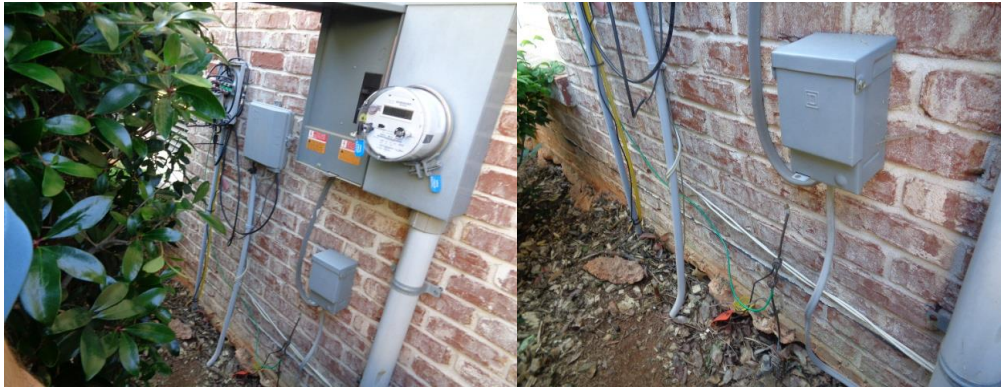
Exposed wiring and no over current protection noted at the meter and heat pump unit.

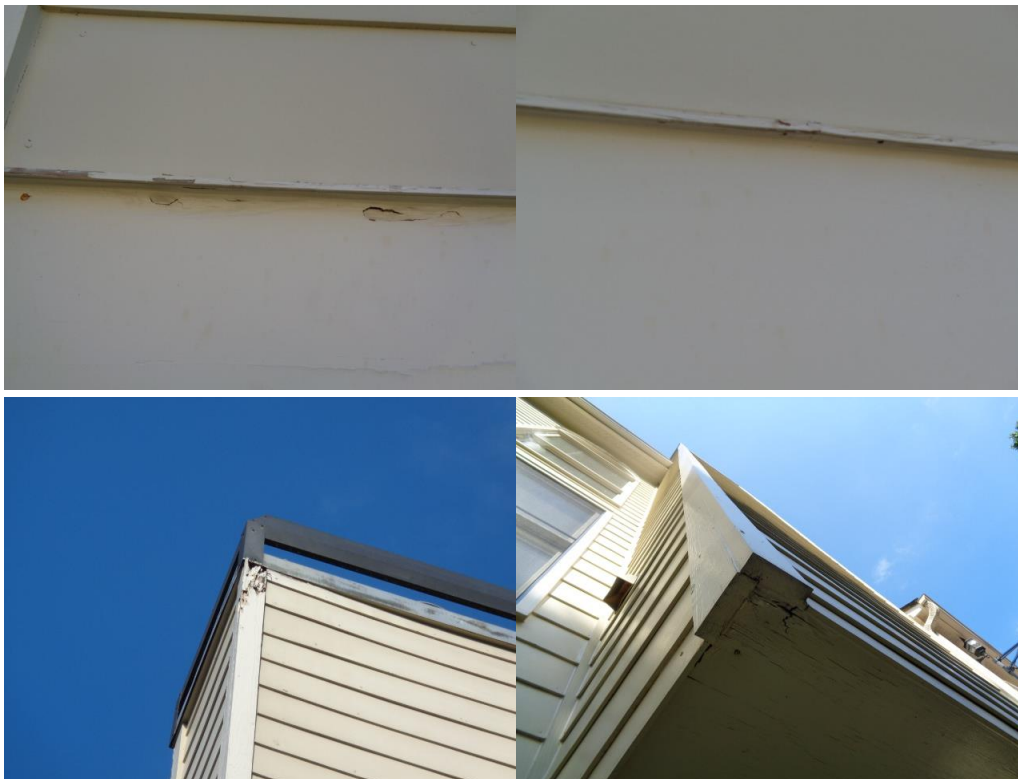
Rot noted at the chimney chase area and wood trim at the sides of the home between the claddings.

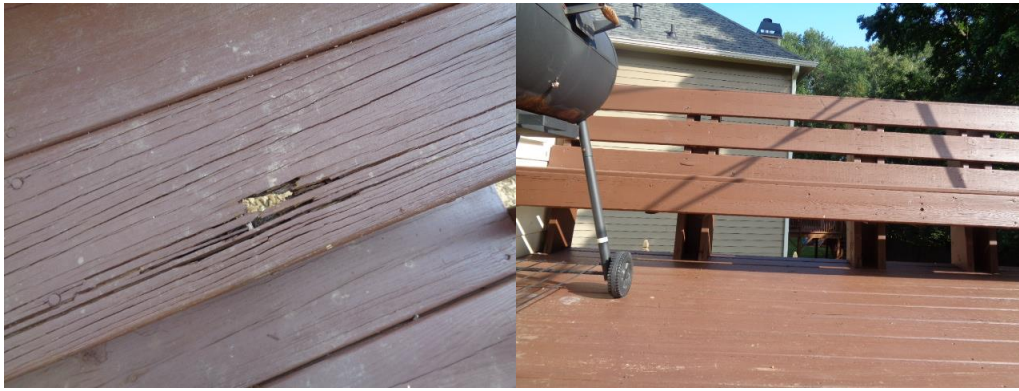
Loose/ damaged treads noted at the deck stairs and excessive openings noted at the deck bench areas.

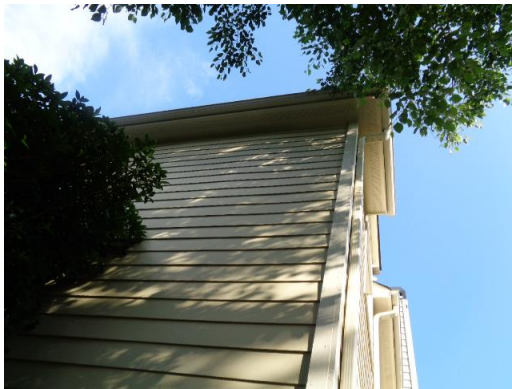
Recommend clearing trees and vegetation around the home.

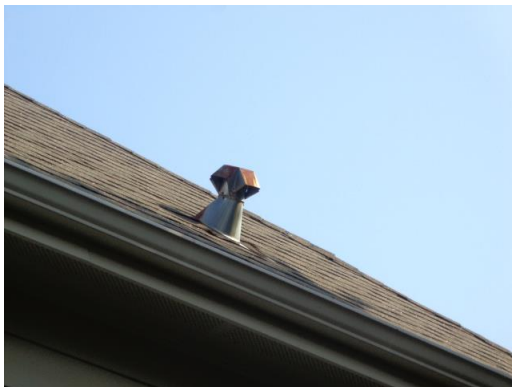
Rusting noted in the exhaust vent cover at the right side roof slope.

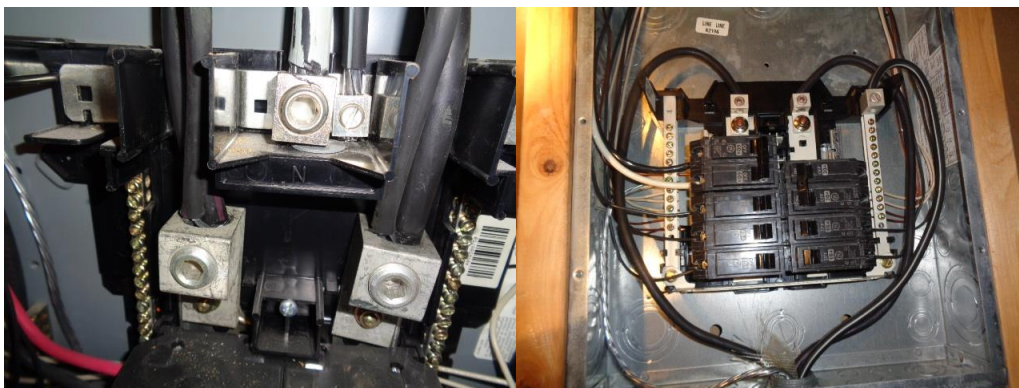
Improper subpanel installation including double taps off of the main service lugs, lack of appropriate over current protection for the feeders utilized, anti-oxidant installation on feeders, improper floating/ bonding for grounds and neutrals.

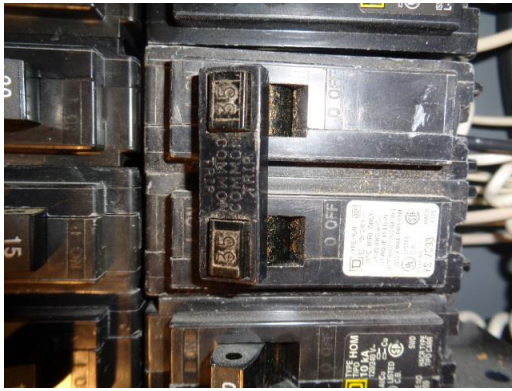
Oversized breaker serving the exterior air condensers.

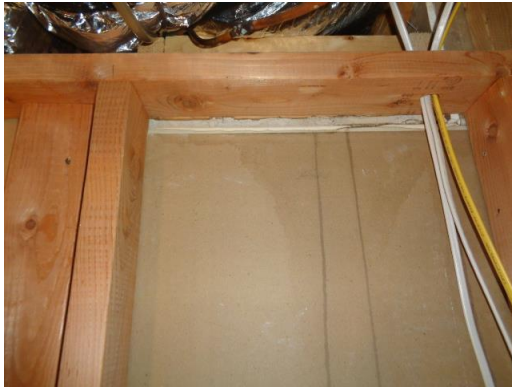
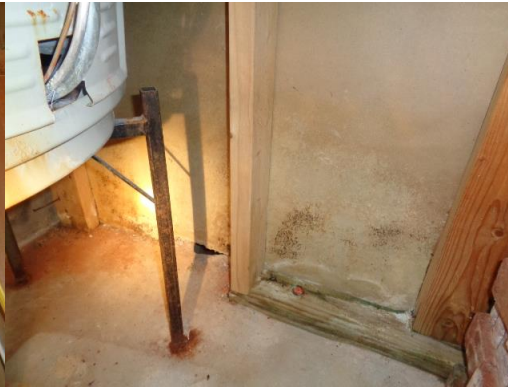
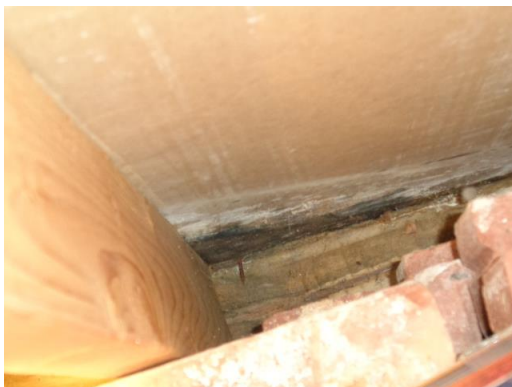
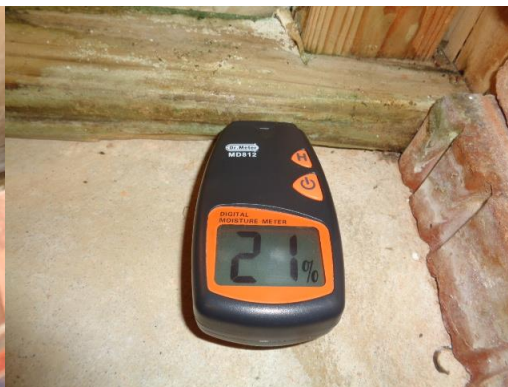
Basement bathroom areas appears to have been constructed without water resistant drywall (green board). Saturation with microbial growth was noted indicating chronic leakage.

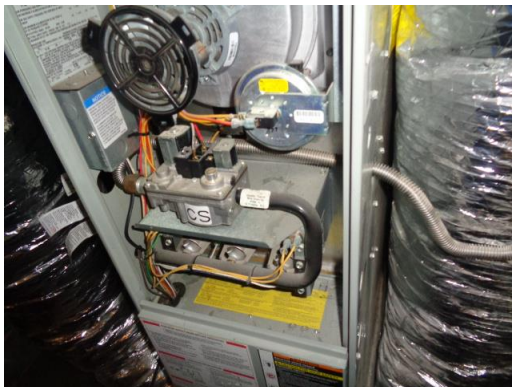
Gas supply improperly flex piped into the furnace burner compartments.

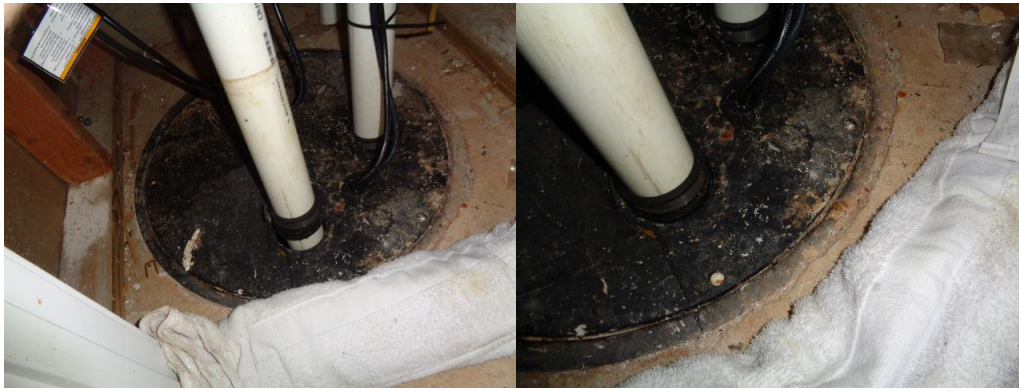
Evidence of amateur sump pump installation at the basement with venting and leakage issues noted.

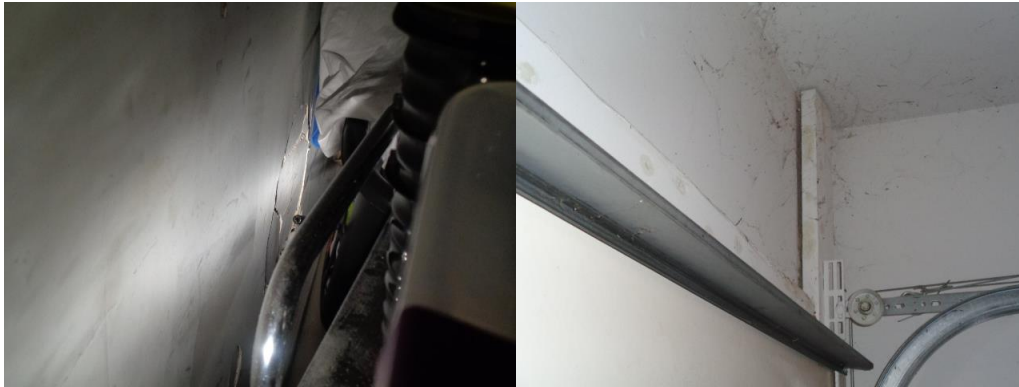
Firewall damage and loose mounting ledgers noted at the garage area.

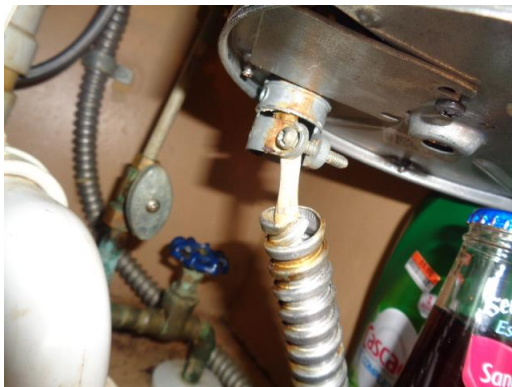
Loose/ damaged conduit noted at the waste disposal circuit.

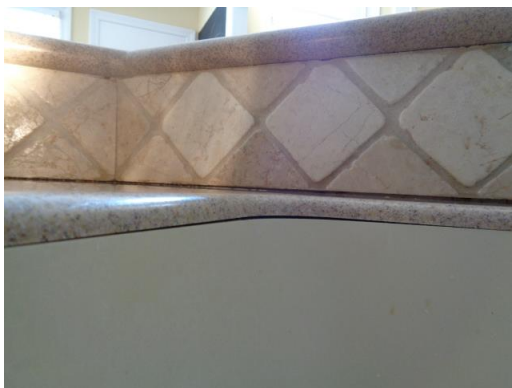
The inset sink fixture is separating from the countertop at the kitchen.

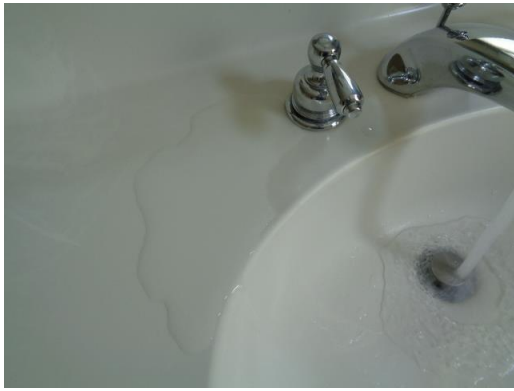
Leaky fixtures noted at the master bathroom sink hot sides.
