Building Inspection Report

Prepared By:
New Haven Home Inspections LLC
2383 Akers Mill Rd. N8
Atlanta, GA 30339

Report Number:
MXXXX

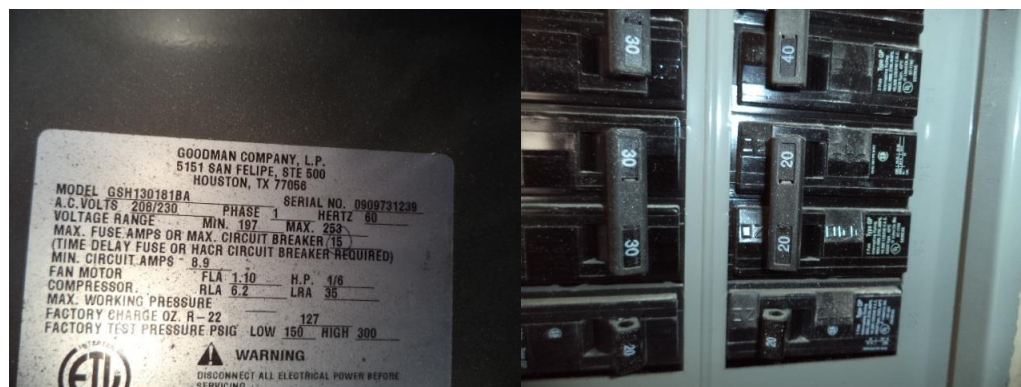
20 amp breaker serving the exterior heat pump unit should be replaced with a 15 amp breaker.

- **Repair:** Oversized breakers within the main distribution panel should be replaced serving the exterior section of the heat pump system. The unit is listed for a maximum over current protection of 15 amps and a 20 amp breaker is installed.

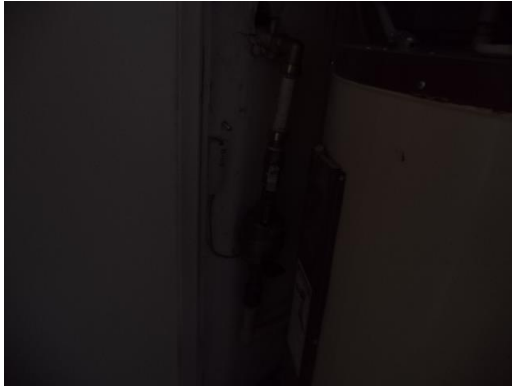
Recommend properly supported the supply piping around the meter area.

- **Repair:** The supply piping lacks adequate support around the meter/ main disconnect.

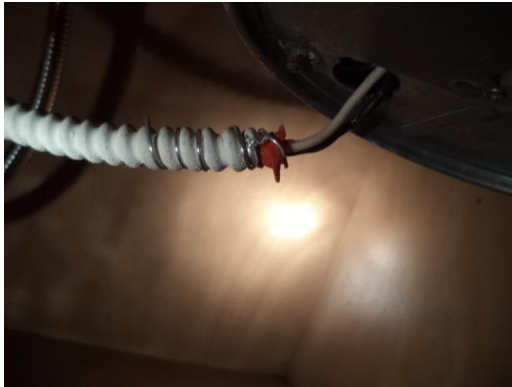
Exposed wiring due to loose/ damaged conduit below the kitchen sink.

- **Repair:** Wiring exposed due to loose/ damaged conduit should be repaired below the kitchen sink at the waste disposal circuit.
- **Repair:** Extension cords should not be used as permanent wiring at the kitchen area serving the microwave oven. This wiring should be removed.

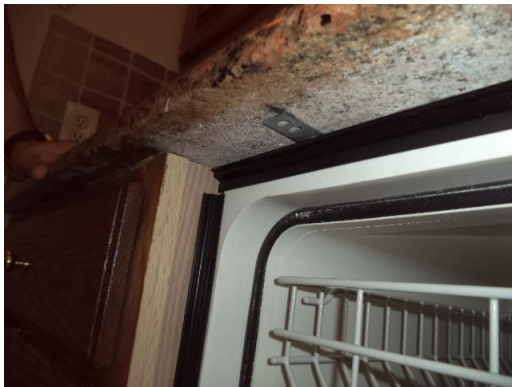
Dishwasher needs to be properly mounted/ attached.

- **Repair:** The dishwasher should be better secured to the counter top or cabinets.

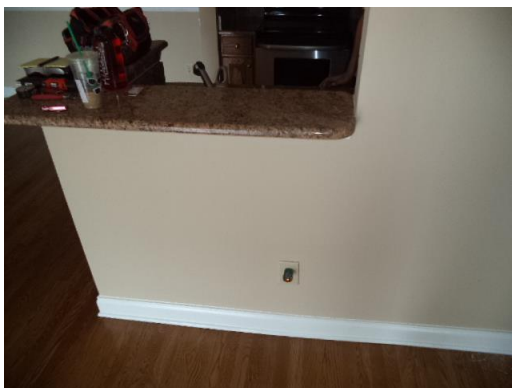
Recommend installing GFCI protected outlets behind the kitchen sink bar area and to the left of the range.

- **Safety Issue:** The installation of a ground fault circuit interrupter (GFCI) is recommended at the kitchen bar area behind the sink and to the left of the range. A GFCI offers increased protection from shock or electrocution.
- **Repair:** The loose outlets should be repaired in the kitchen by the range unit, by the laundry entry, and at the front bedroom by the entry.
- **Repair:** Missing outlet cover plates should be replaced to avoid a shock hazard in the master bathroom.

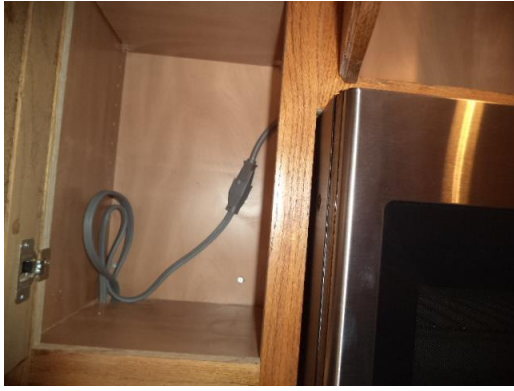
Extension cord wiring noted in the kitchen for the microwave unit.

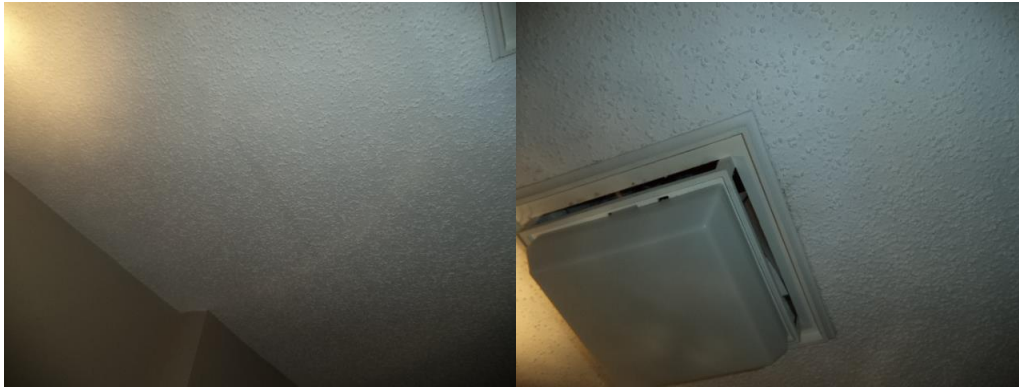
Localized water staining noted at the master bathroom area.

- **Monitor:** An apparent water staining was noted in the master bathroom ceiling. The area was dry at the time of the inspection.
- **Monitor:** The vanity mirror in the master bathroom has sustained localized damage near the counter.
