Building Inspection Report

Prepared By:
New Haven Home Inspections LLC
2383 Akers Mill Rd. N8
Atlanta, GA 30339

Report Number:
MXXXX

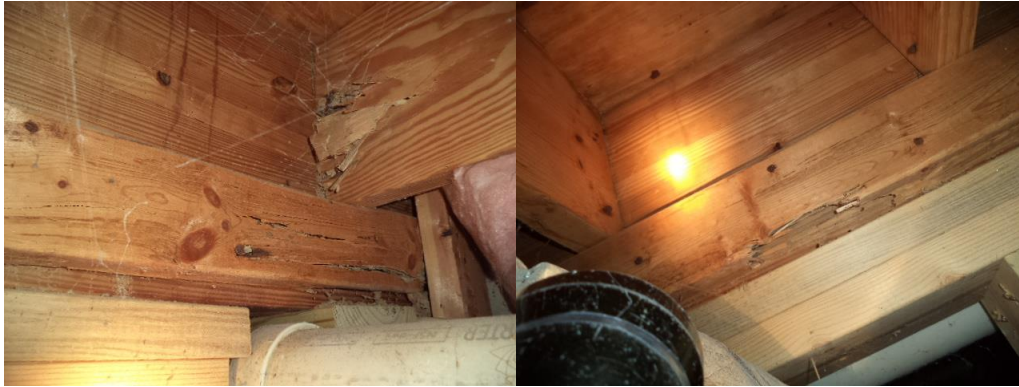
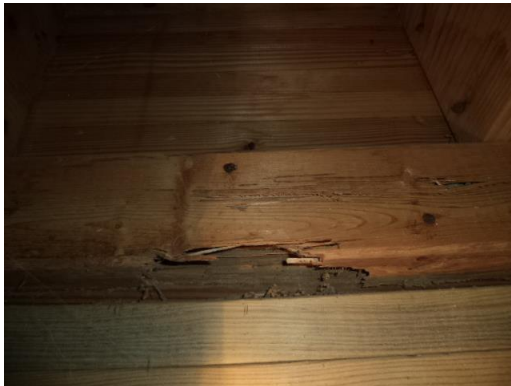
Substantial termite damage noted in the girder, joists, ledgers, and sills at the left side of the home.

- **Major Concern, Repair:** The floor structure shows evidence of substantial damage to the structure at the central girder, joists, sill plates, and ledgers due to wood destroying organism activity. This weakens the structure and causes building damage. Damaged wood should be repaired or replaced and the conditions that have promoted the damage/ rot should be corrected. A framing repair company or structural engineer who is expert in wood framing be consulted to further evaluate this condition and the remedies available.

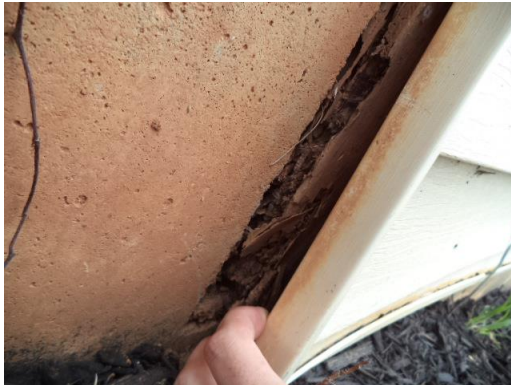
Termite damage noted at the front cripple wall.

- **Repair:** The floor structure shows evidence of localized rot and wood destroying organism damage at the front cripple wall outside the garage area. Rot/ damage weakens the structure and causes distress to the building. Damaged wood should be repaired or replaced and the conditions that have promoted the rot (such as wet conditions and/or poor ventilation) should be remedied.

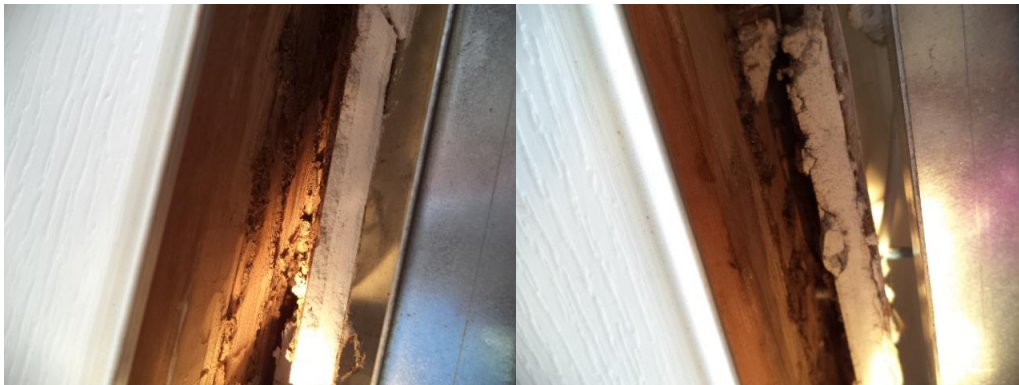
Termite activity and localized damage at the garage area.

- **Repair:** Evidence of wood destroying insect damage/ activity was observed at the garage area, front cripple wall, and left side floor system; there is risk of additional hidden damage since termites can do a substantial amount of damage. If the property has not already been treated, a licensed pest control specialist should be engaged to eliminate further wood destroying insect activity within the home. Damaged wood should be repaired or replaced. Any wood soil contact should be eliminated.

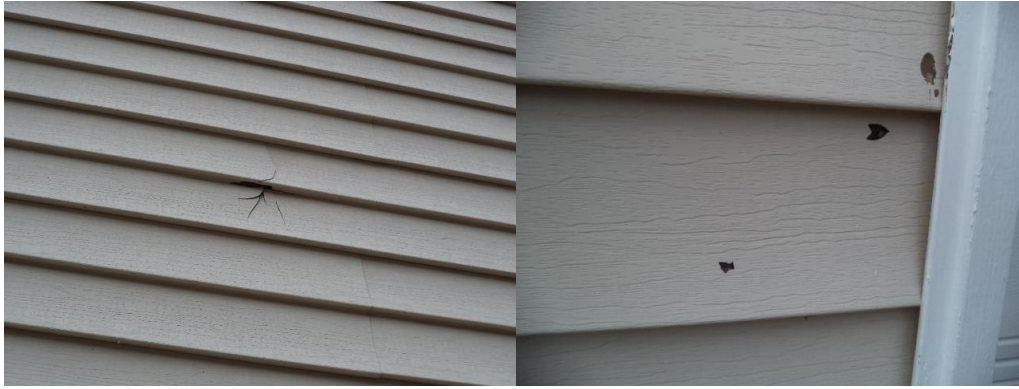
Localized damage noted in the vinyl siding.

- **Repair:** The exterior vent cover should be replaced at the front left corner dryer vent with a closing cover.
- **Repair:** It is recommended that the damaged siding be replaced or repaired at the right side and front left corner of the home.
- **Monitor:** Close grade proximity was noted at the siding termination at the left side of the home.

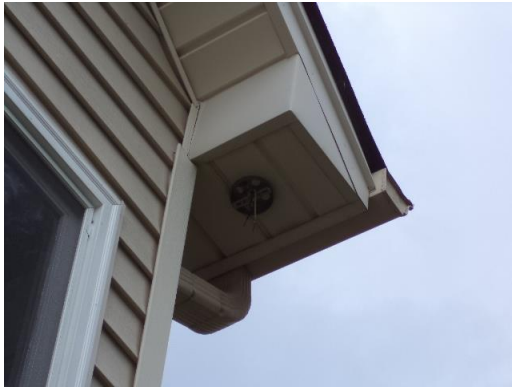
Light fixture was noted missing at the right rear corner of the home.

- **Repair:** The missing light fixture should be repaired or replaced at the right rear exterior corner.
- **Repair:** The light fixture covers are missing at the basement area.

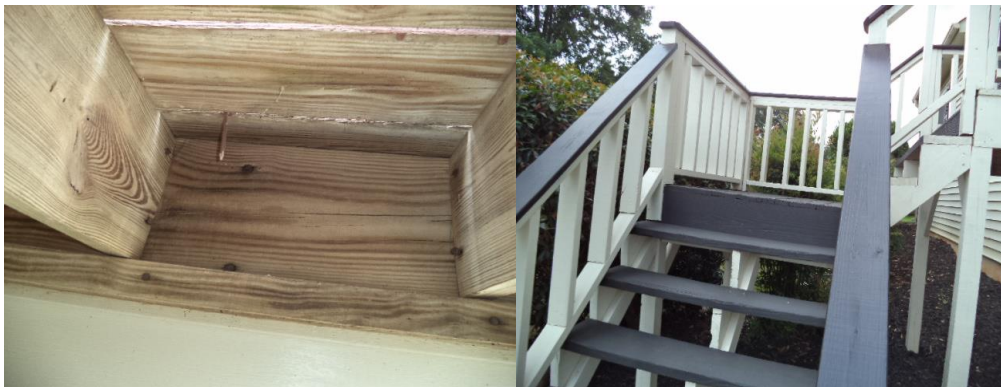
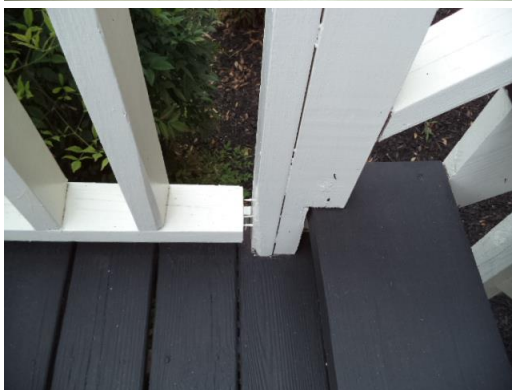
Front porch lacks lagging/ anchorage with loose railings and excessive openings.

- **Repair, Safety Issue:** The porch railings are loose. It is recommended that this be repaired for improved safety.
- **Repair, Safety Issue:** The openings in the porch railing are large enough to allow a child to fall through. It is recommended that this be altered for improved safety.
- **Repair, Safety Issue:** The porch should be properly lagged/ anchored to the structure.
- **Repair, Safety Issue:** The porch should be flashed at the building attachment.

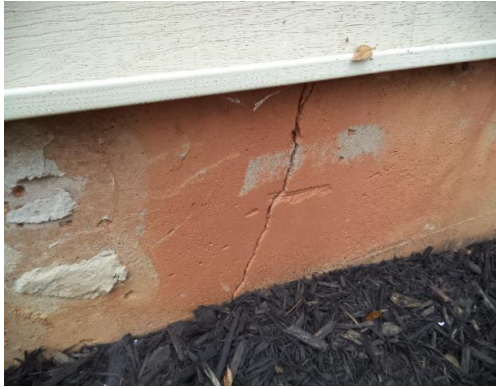
Settlement cracking noted at the front wall.

- **Monitor:** Larger than typical foundation settlement cracking was observed at the front wall of the foundation. The amount of movement which has occurred is not likely to have caused other damage to the structure but this area should be monitored. If additional movement occurs, more costly repairs might be necessary. The rate of movement cannot be predicted during a one-time inspection. These cracks may need sealing on the exterior to prevent moisture penetration.
- **Monitor:** There is some evidence that past repairs were performed outside the garage area, possible a pier or mud jacking.

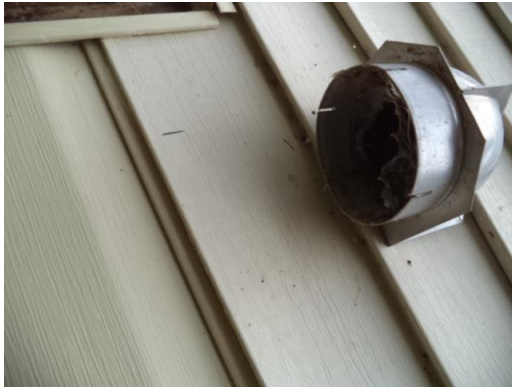
Recommend installing a proper dryer vent cover at the front left corner of the home.

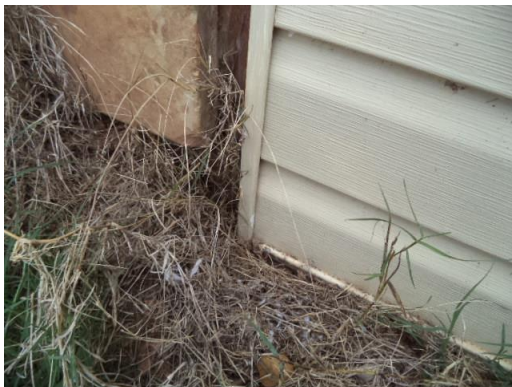
Siding to grade proximity issues noted at the front and left sides of the home.

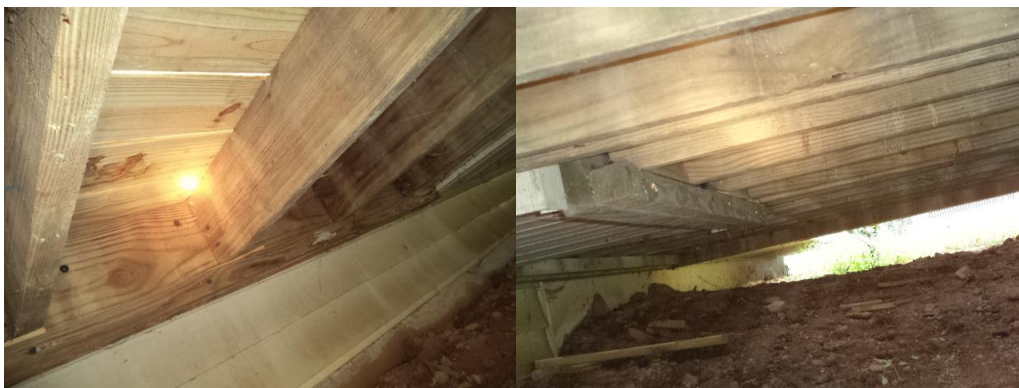
Deck lacks flashing with proper anchorage/ lagging with failing end bearing for joists at interior ledgers.

- **Repair, Safety Issue:** The deck railings are loose and needs repair.
- **Repair, Safety Issue:** The deck should be properly lagged/ anchored to the structure.
- **Repair, Safety Issue:** The deck should be flashed at the building attachment.
- **Repair, Safety Issue:** The deck support joists have some failing end bearing at the interior ledger near the chimney chase.

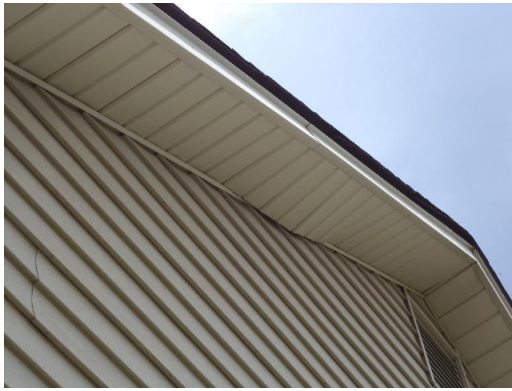
Loose soffits noted at the left side of the home.

- **Repair:** The loose soffit should be repaired at the left side of the home.

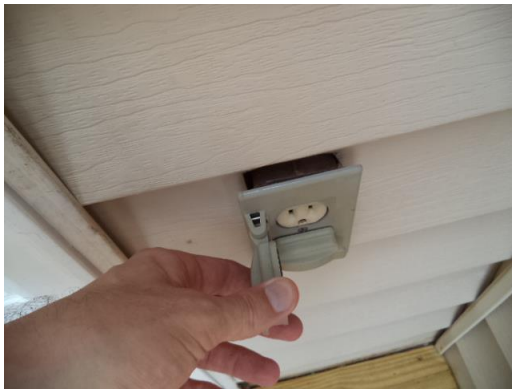
Loose outlet noted at the rear exterior.

- **Repair:** An outlet is loose at the rear exterior.
- **Repair:** Some outlets are damaged in the 2nd floor front left bedroom due to painting.
- **Repair:** Missing outlet cover plates should be replaced to avoid a shock hazard at the basement mechanical room and master bedroom.
- **Safety Issue:** The installation of a ground fault circuit interrupter (GFCI) is recommended at the garage area, rear exterior, and for all kitchen counter based outlets. A GFCI offers increased protection from shock or electrocution.

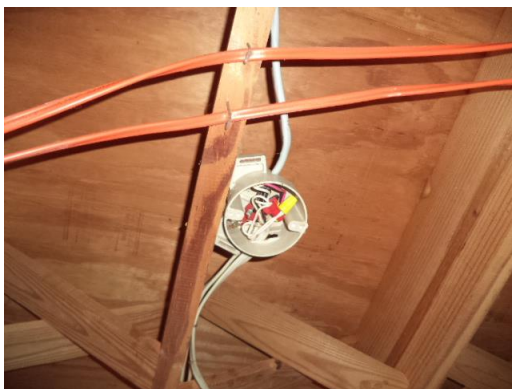
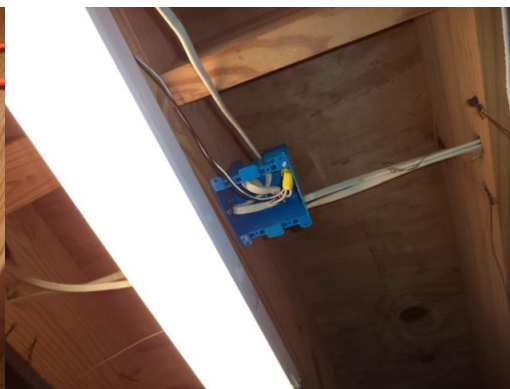
Open junction boxes noted in the garage area.

- **Repair:** Extension or spliced appliance cords should not be used as permanent wiring at the kitchen vent fan unit. This wiring should be removed.
- **Repair:** Improper electrical connections should be repaired at the spliced condensate pump cord into the air handler service disconnected. The circuit should be wired to an appropriate 110 circuit.
- **Safety Issue:** All junction boxes should be fitted with cover plates in the garage area, in order to protect the wire connections.

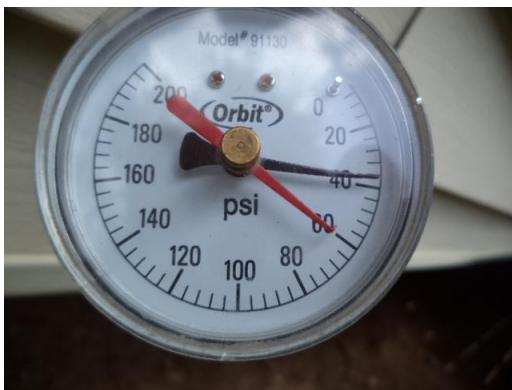
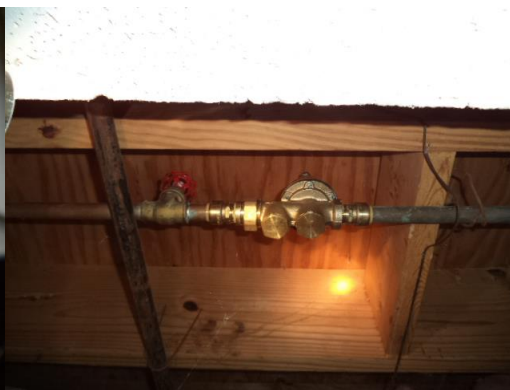
Static plumbing supply pressure tested at 38 psi at the time of inspection below the minimum of 40 psi. Recommend adjusting at the regulator to standard pressure of roughly 60 psi but not exceeding the maximum 80 psi.

- **Repair:** As the static water pressure of the supply plumbing system tested below the minimum 40 psi, it would be wise to adjust the pressure regulator. The pressure should be no lower than 40 psi and no higher than 80 psi; most homes are set roughly at 60 psi.

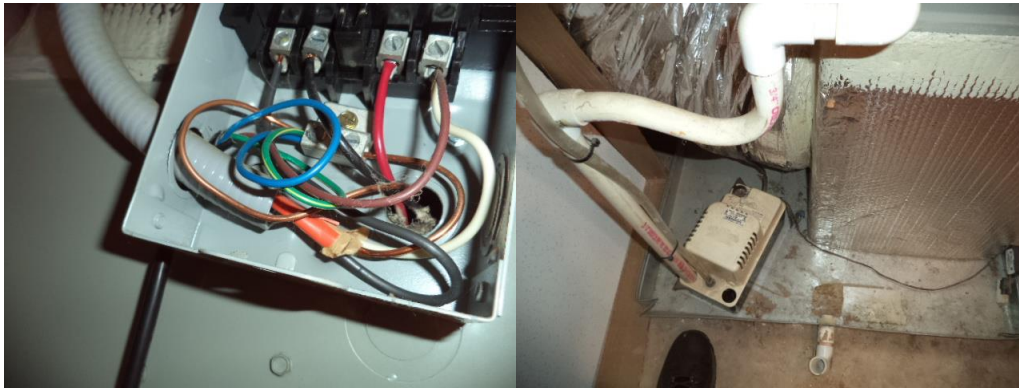
Condensate pump power supply spliced into the 220 service disconnect at the air handler.

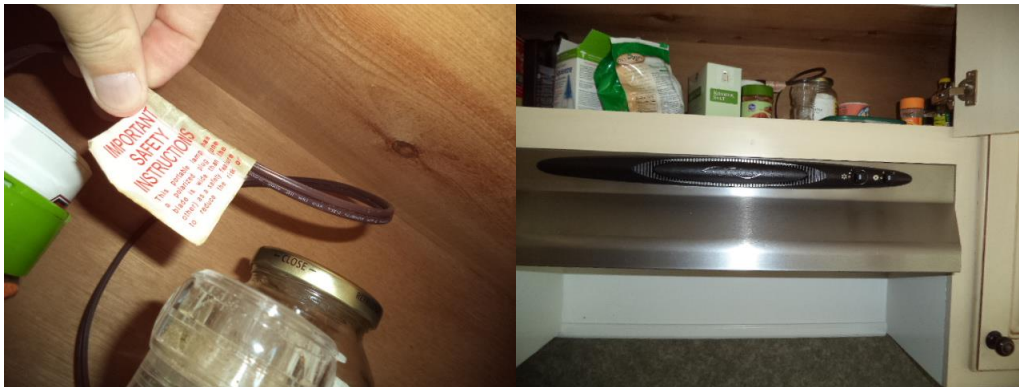
Extension/ appliance cord splicing noted at the kitchen vent unit.

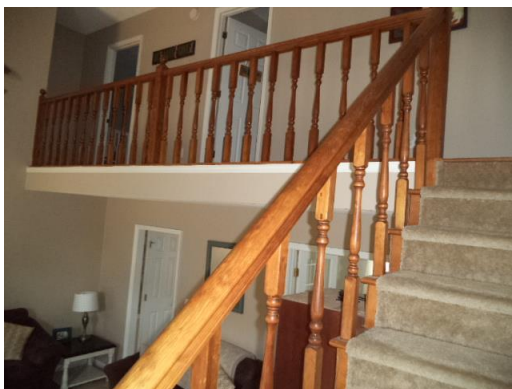
Loose rails, excessive openings, and loose tread noted at the main stairwell/ landing area.

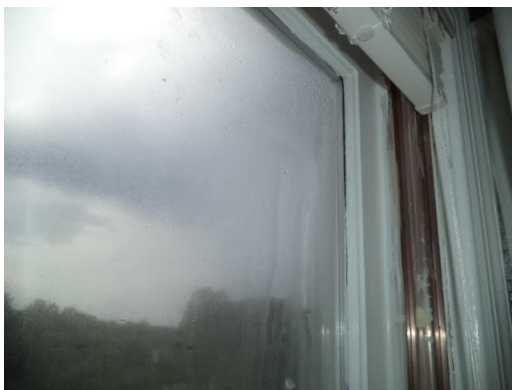
Lost seal noted in the 2nd floor hall bathroom window.

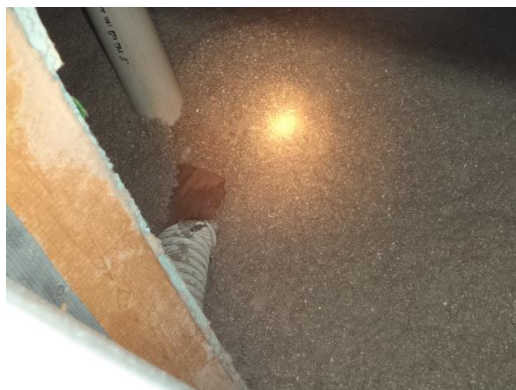
Recommend venting the exhaust fan to the building exterior instead of the knee wall attic space.

- **Repair:** Exhaust vent pipes from the bathroom(s) should be vented to the building exterior instead of the knee wall attic space.
- **Repair:** Recommend insulating the knee wall attic access in the 2nd floor hall closet.

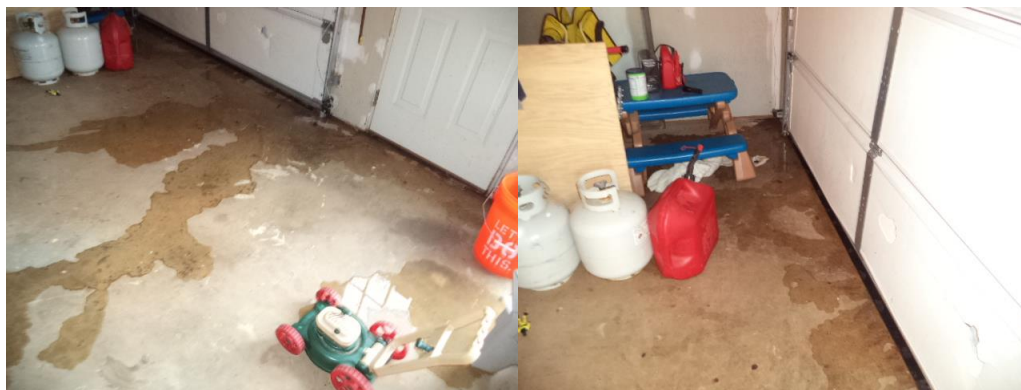
Water entry noted at the garage area.
